**NAVAL FACILITIES ENGINEERING SERVICE CENTER**  
Port Hueneme, California 93043-4370

## **Special Publication** **SP-2081-SHR**

# **AIRFIELD PAVEMENT VOID DETECTION TECHNOLOGY**

**April 2000**

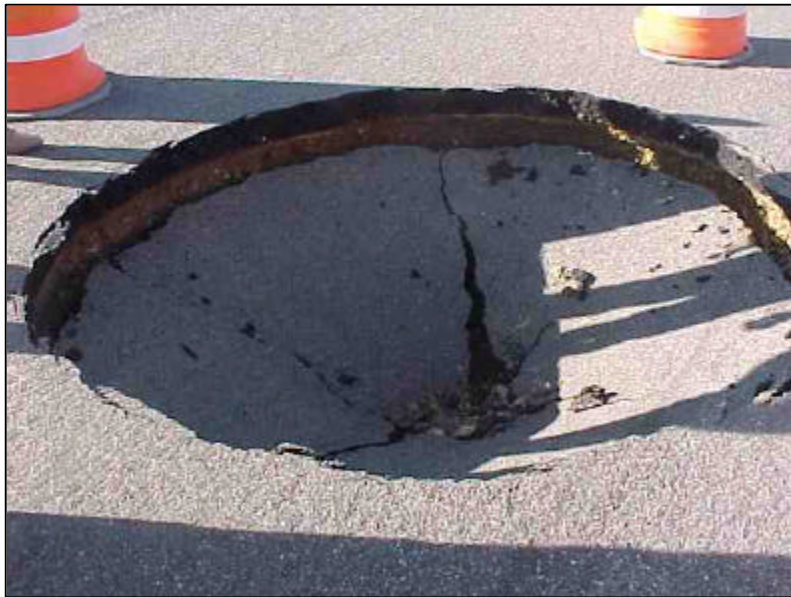
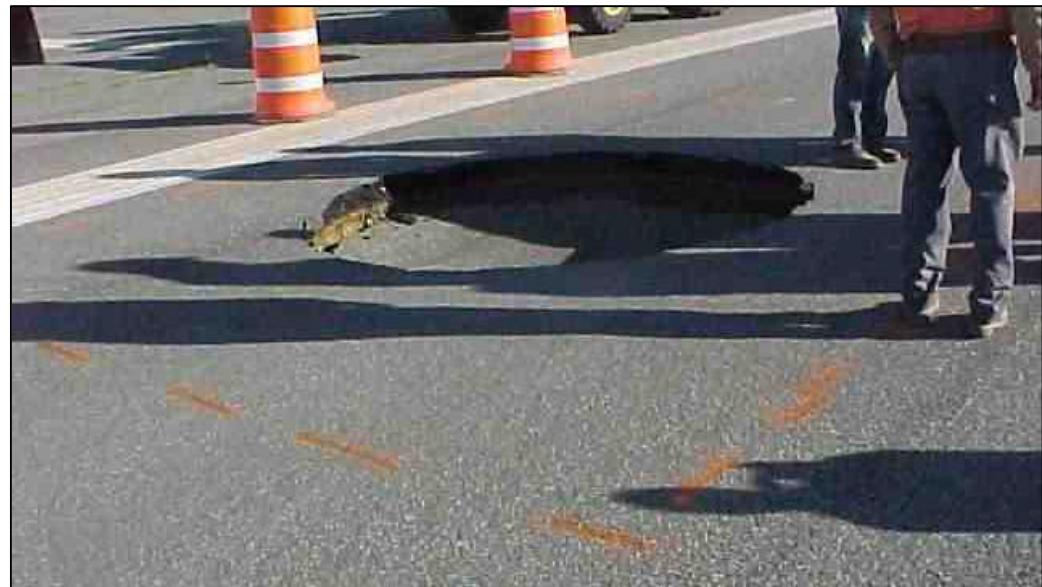
FIGURE 1. PAVEMENT FAILURE AT MCAS CAMP PENDLETON

## **MCAS Camp Pendleton** **Runway Failure**

- 6' diameter by 4' deep sinkhole
- on runway
- no aircraft involved

- Feature R3-1, NW edge, between TWA and TWB
- 1999 PCI = 79
- 1993 PCN = 47/F/C/W/T
- no utility line
- sinkhole due to water table variation (between -2 to -7 feet)

- MCAS Pendleton (March 2000), where a 6-foot diameter, 4-foot deep sinkhole surfaced on the runway (Figure 1). The pavement included 7 inches of AC on 12 inches of Class II road base, over a hard sandstone strata. It appears that the sandstone was washed away by a fluctuating water table. Repair was completed with a 12-ft by 30-ft full-replacement patch.

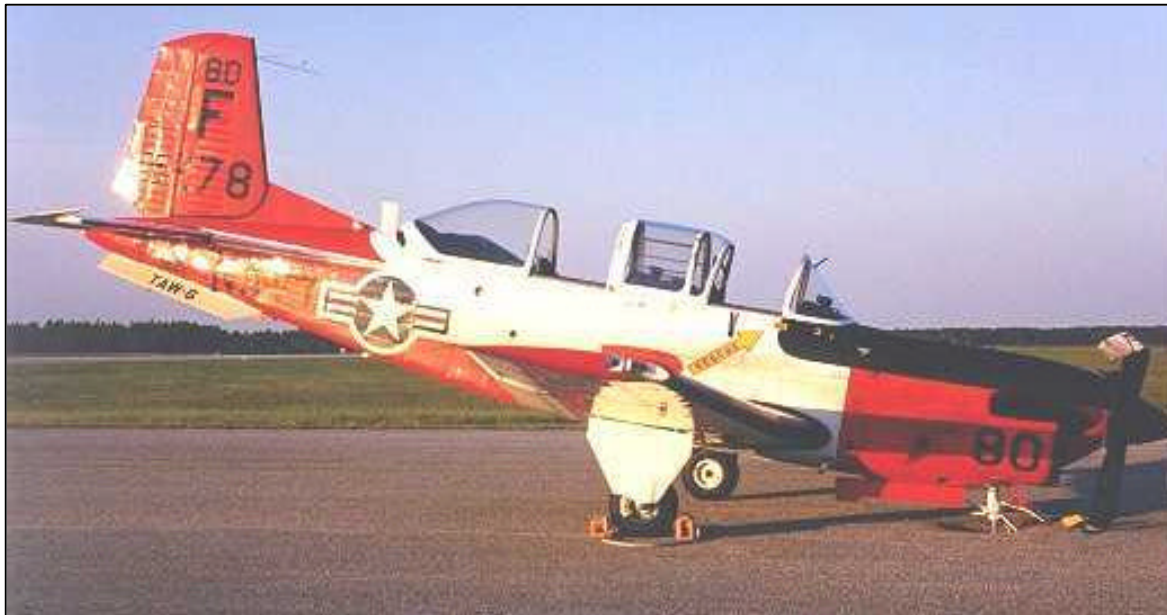
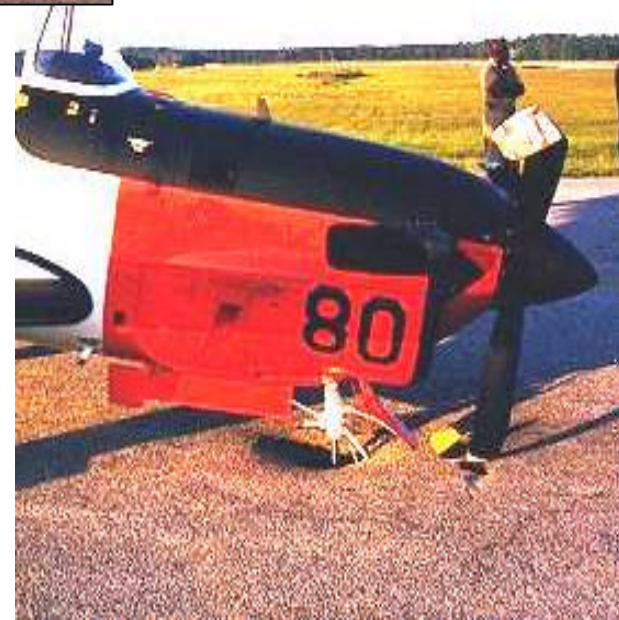
FIGURE 2. PAVEMENT FAILURE AT NAS PENSACOLA

## NAS Pensacola Taxiway Failure

- TWA3 (LT2/3 @RW25R to25L)
- Nose gear sunk 12 inches
- 1999 PCI = 57 (high SCI)
- 1999 PCN = 48/F/B/W/T
- T-34C ACN = 3 to 5
- Pipe leak

On 20 May 1999, a T-34C aircraft fell into a 12-inch deep hole that formed in taxiway LT2/3 (or TWA3), between runway features RW25R and RW25L, at NAS Pensacola. This pavement failure was due to local base and subgrade erosion from a leaking drain pipe under the taxiway. In July 1999, the Naval Facilities Engineering Service Center (NFESC) was tasked by the Naval Facilities Engineering Command (NAVFACENGCOM or NAVFAC) to determine the extent of potential voids near all drain pipes under the runways, taxiways and aprons. NFESC, in cooperation with NAVFACENGCOM Southern Division, and with support from NAS Pensacola, completed an assessment of the airfield pavements above drain pipes and found several other areas with loose subgrades, and some with actual voids. Several destructive and nondestructive techniques were used in detecting the voids, and the reliability of each technique was assessed. A final report was completed by December 1999 [1], and most deficient areas have already been repaired.

- NAS Pensacola (May 1999), where the front gear of a T-34C punched through the pavement on taxiway LT2/3 (Figure 2). The nose gear came to rest about twelve inches below the pavement surface, resulting in propeller impact on the pavement. This failure was due to a leaky storm drain pipe that eroded part of the subgrade [1]. In this incident, voids were detected using the Heavy Weight Deflectometer (HWD) [1]. The Air Force Research Laboratory (AFRL) supported the Navy in determining the extent of some of the void using a Ground Penetrating Radar (GPR) system [1, 8]. The Air Force Civil Engineer Support Agency (AFCEA) verified the voids and weak areas using an Electronic Cone Penetrometer (ECP).

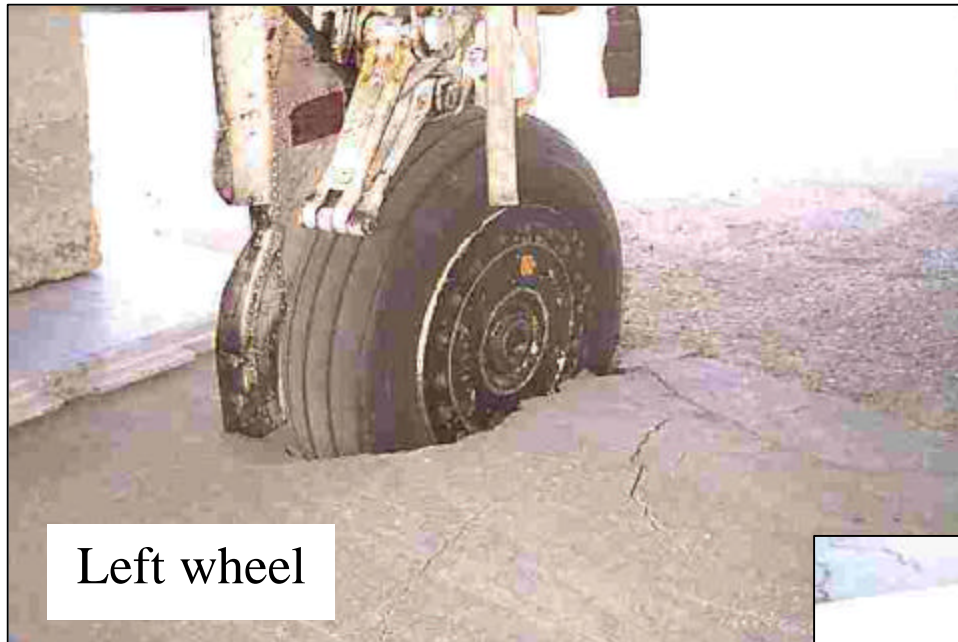
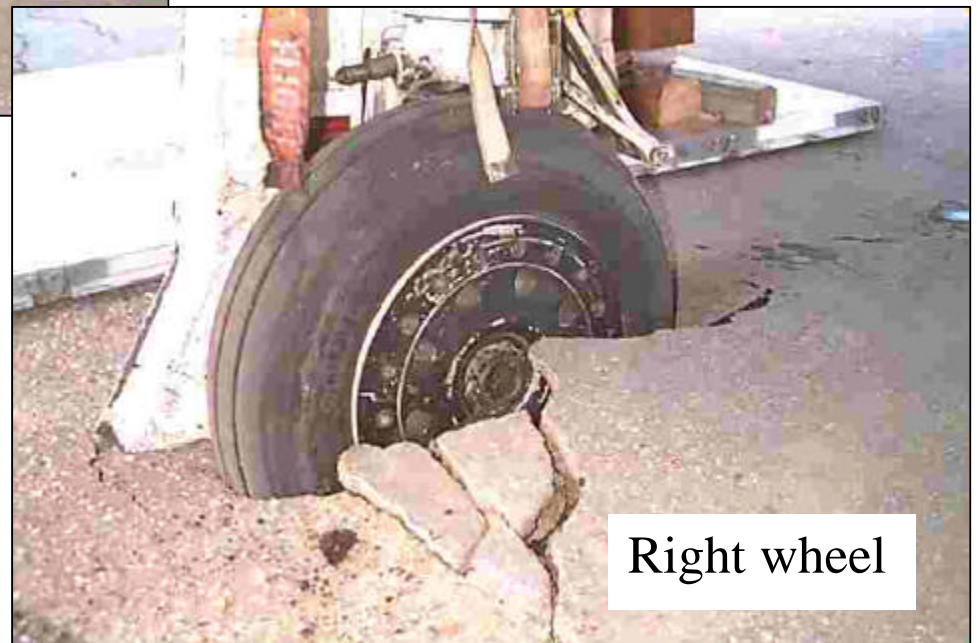
FIGURE 3. PAVEMENT FAILURE AT OLF SAN NICOLAS

## OLF San Nicolas Island Apron Failure

- F-4 Phantom II
- 2"+2.5" AC

- Feature PA1-2
- 1992 PCI = 59
- 1994 PCN = 12/F/C/Y/T
- F-4 ACN = 15 to 24
- Base washed out

- OLF San Nicolas Island (March 1998), where both main gears of an F-4 punched through an AC pavement (Figure 3), and where additional sinkholes in the runway and nearby were found (Figure 4). The aircraft was being towed from ramp to hangar for maintenance and to avoid obstacles on left side of taxiway centerline the aircraft was towed through an unmarked asphalt area. The aircraft tow was stopped just prior to a concrete pad, which was the location of the failure. In this case the pavement was very weak, the base was saturated and had been eroded [9].

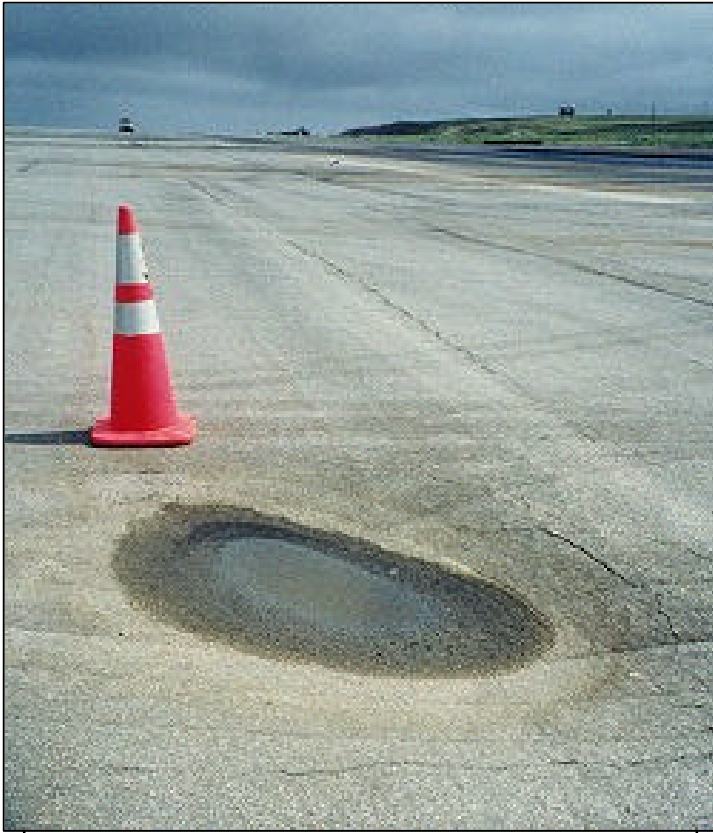
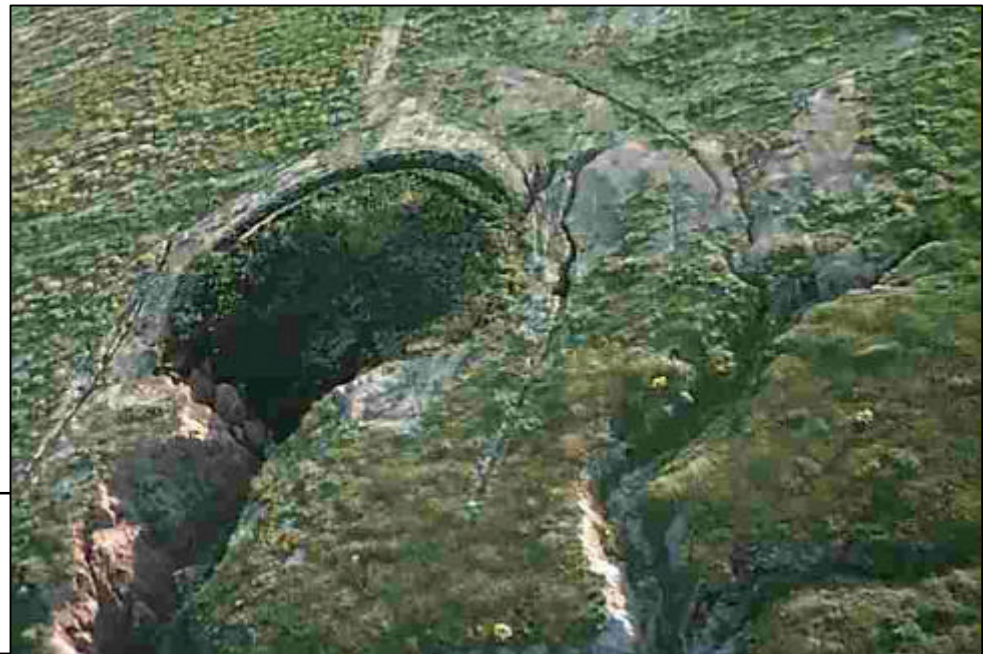
FIGURE 4. SINKHOLES AT OLF SAN NICOLAS

Sinkhole in Runway R12-1B

Sinkhole near  
Runway

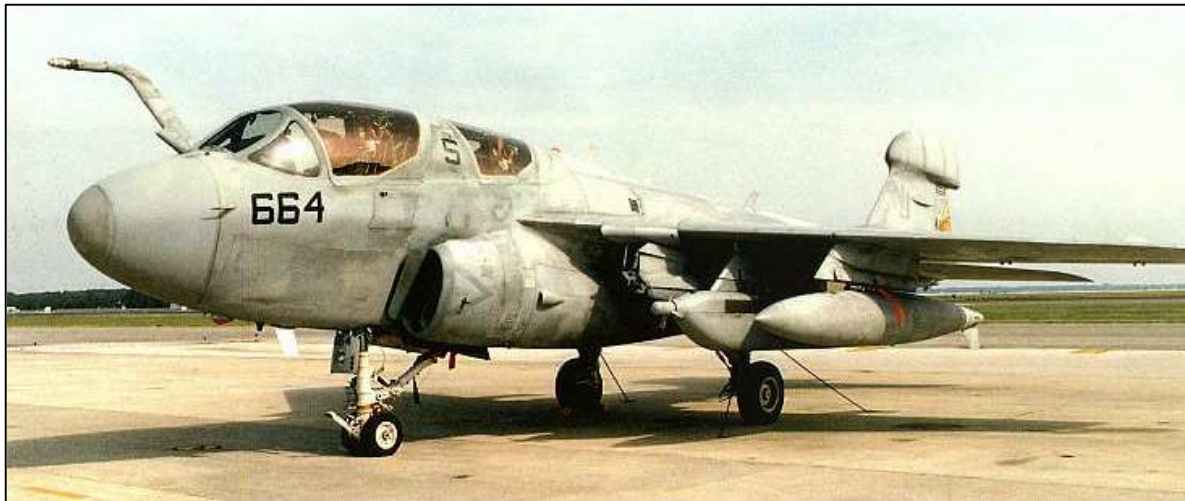
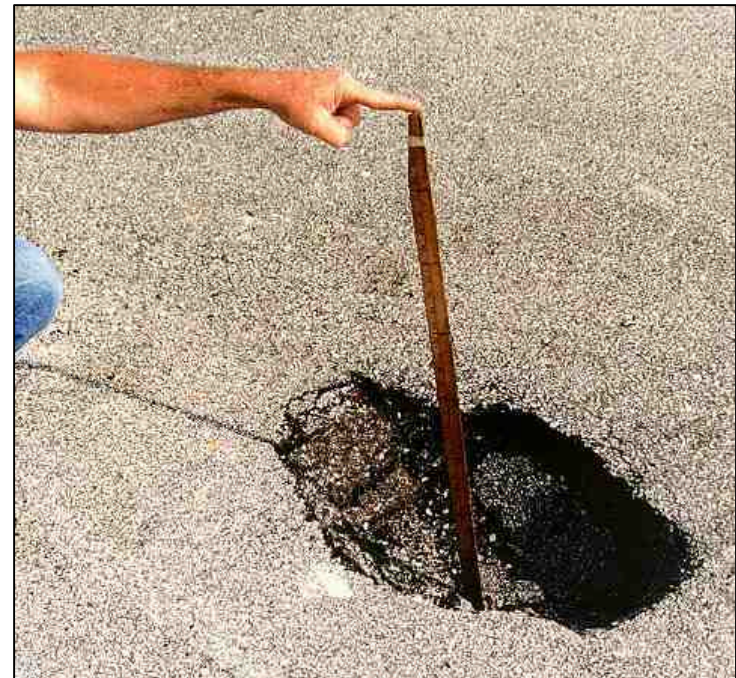
FIGURE 5. PAVEMENT FAILURE AT NAS JACKSONVILLE

## **NAS Jacksonville** **Taxiway Failure**

- EA-6B Prowler

- Section TA/5 (now reconstructed)
- North of Hangar 117
- 3" AC
- 1998 PCI < 40
- A-6 ACN = 11 to 26
- Old clay pipe collapsing and leaking at joints

- NAS Jacksonville (1998), where several aircraft punched through an asphalt pavement (Figures 5 and 6). The taxiway where the incidents occurred had only 3 inches of deteriorated asphalt, on top of a leaky old clay pipe. The taxiway has since been reconstructed.

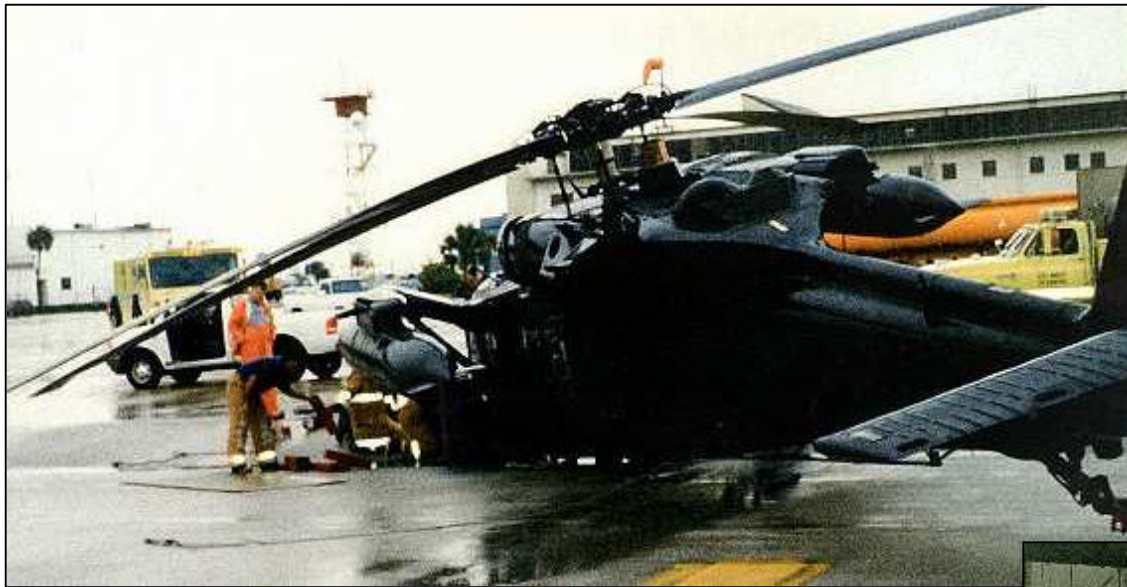
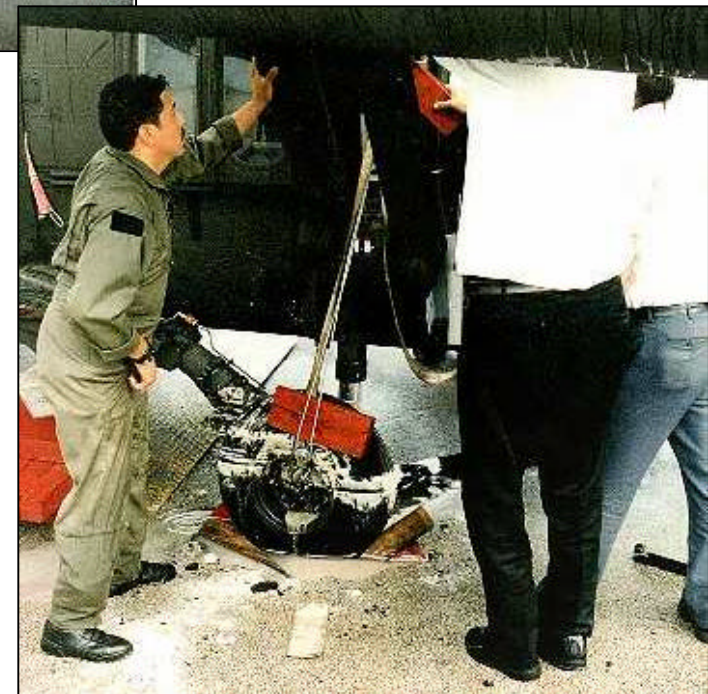
FIGURE 6. PAVEMENT FAILURE AT NAS JACKSONVILLE

## NAS Jacksonville Taxiway Failure

- UH-60 Black Hawk

- Section TA/5 (now reconstructed)
- North of Hangar 117
- 3" AC
- 1998 PCI < 40
- UH-60 ACN = 4.2 to 5.7
- Old clay pipe collapsing and leaking at joints

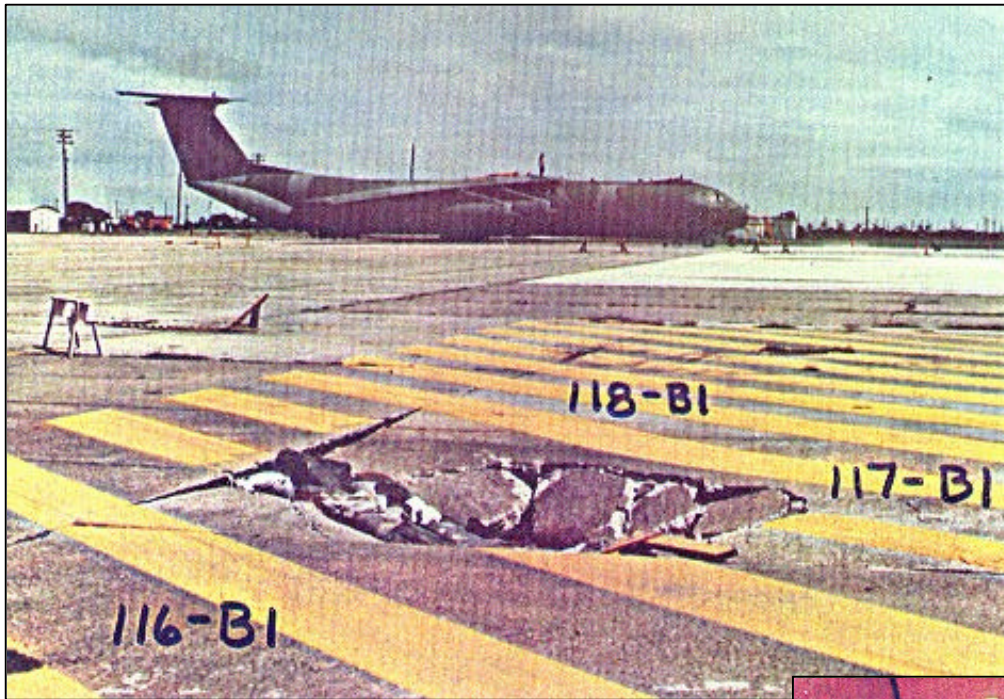
FIGURE 7. PAVEMENT FAILURE AT NAS CORPUS CHRISTI

## NAS Corpus Christi Apron Failure

- C-141 Starlifter
- 11" PCC
- South of Hangar 51

- Section AP1-4
- 1993 PCI = 65
- 1996 PCI = 10
- 1996 PCN = 7/R/C/W/T
- C-141 ACN = 41 to 65
- Sewer line in silty sand

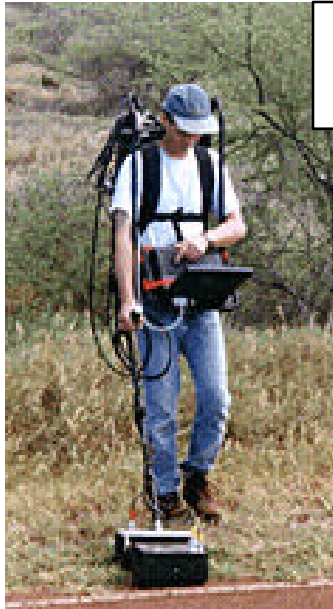
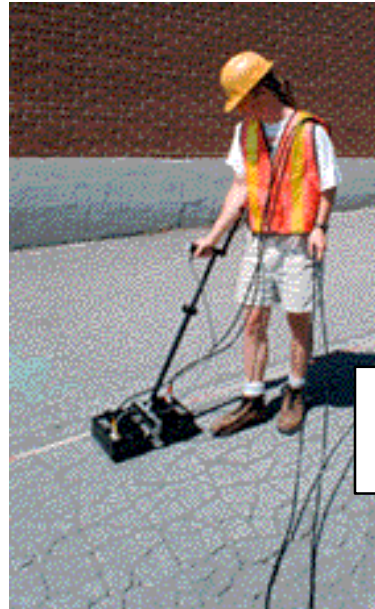
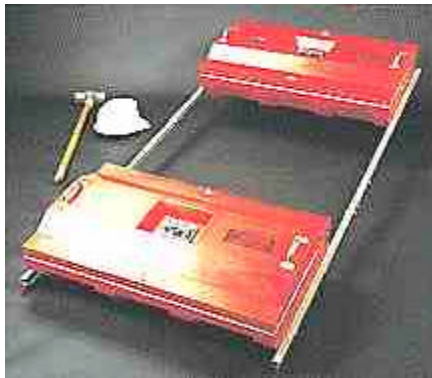
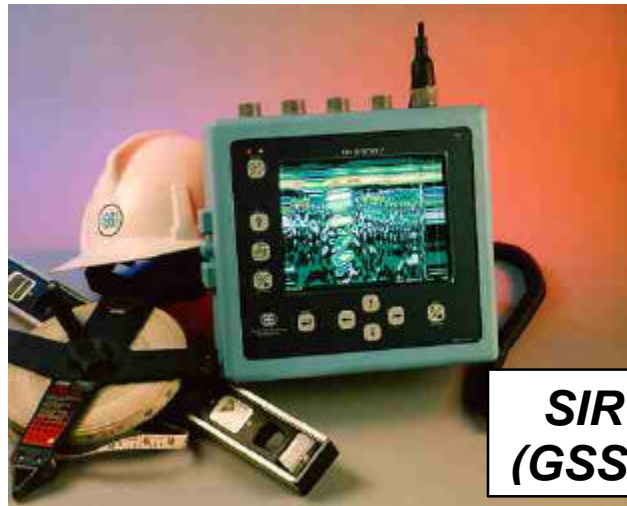
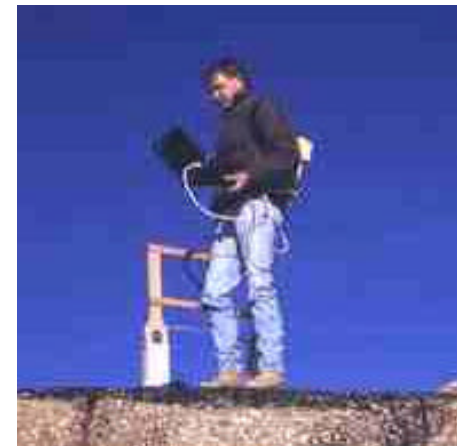
FIGURE 11. SAMPLE OF PORTABLE, COMMERCIALY AVAILABLE GPR SYSTEMS

***LWT GPR  
(Ensco)***

***pulseEKKO  
(SenSoft)***

***Towed GPR  
(Exp Instruments)***

***SIR  
(GSSI)***

***LWT GPR  
(MALA)***

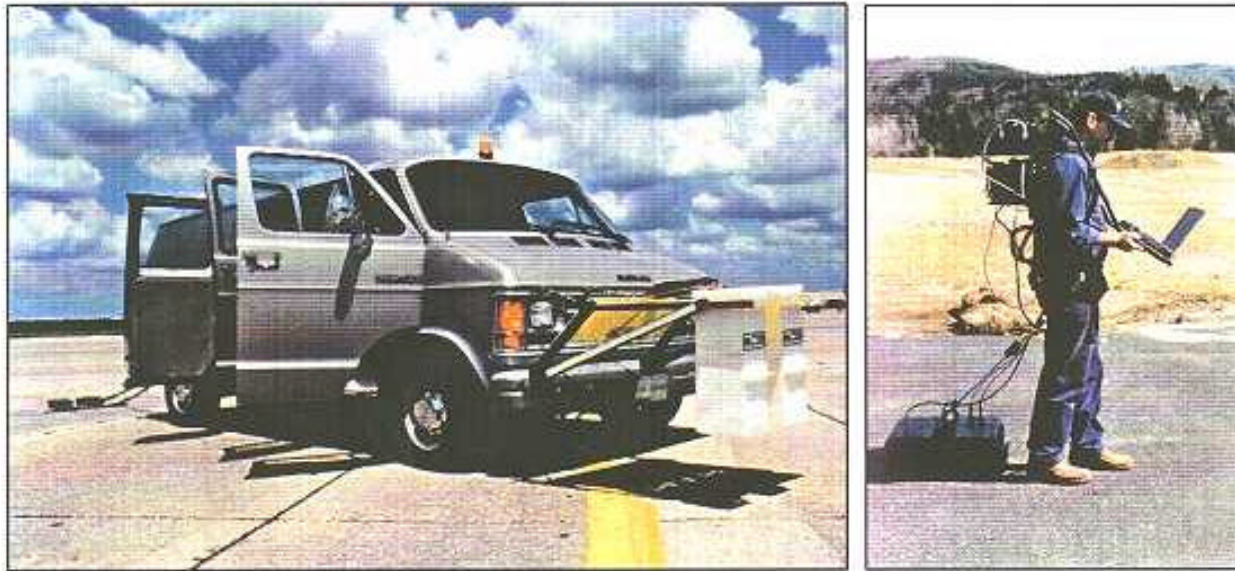
(a) AFRL-MLQC van-mounted and portable GPR System.

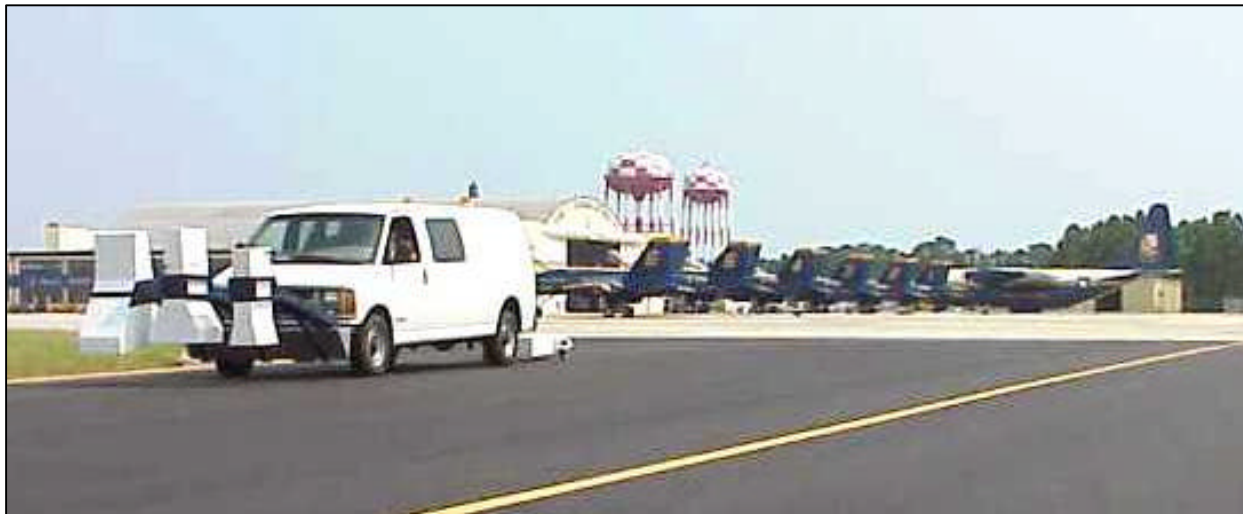
(b) ERDC-WES four-antenna GPR System at NAS Pensacola  
(with 250, 500, and 1000 MHz antennas in the front, and 100 MHz in the back).
